Smoke and Dye-Water Observation Summary

Western Run Pilot Project - Baltimore Maryland

Dye Test 67

INSPECTION REPORT

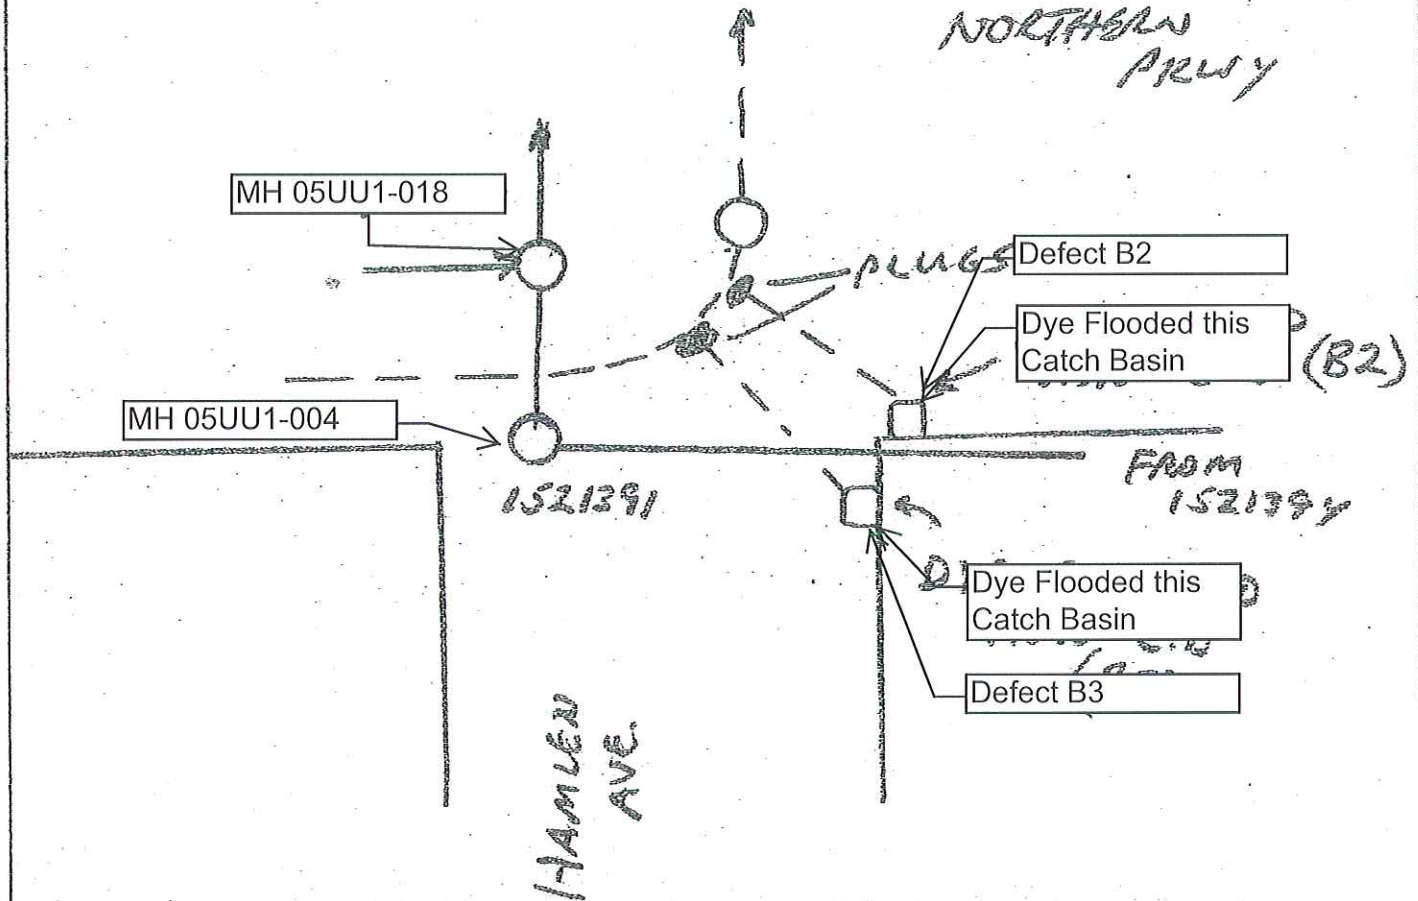
RESULT CODES		SOURCE TYPE CODES		
1. POSITIVE	1. MAIN SEWER	5. DOWN SPOUT	9. STAIRWELL DRAI	13. STORM DRAIN
2. NEGATIVE	2. SERVICE LINE	6. DWNSPT CONN.	10. FOUNDATION DRAIN	14. CATCH BASIN
3. CANNOT TEST	3. TRANSITION JOIN	7. AREA DRAIN	11. BUILDING INTERIOR	15. STORM MH
	4. CLEAN OUT	8. DRIVEWAY DRAIN	12. MH FRAME/SEAL	16. STORM DITCH
Additional Comments: LAMPING THE LINE, THE SAME S.C. LEAKED FROM TEST B2 AS DID FROM B3 BUT WITH LESS INTENSITY. DID NOT TV IT AGAIN.

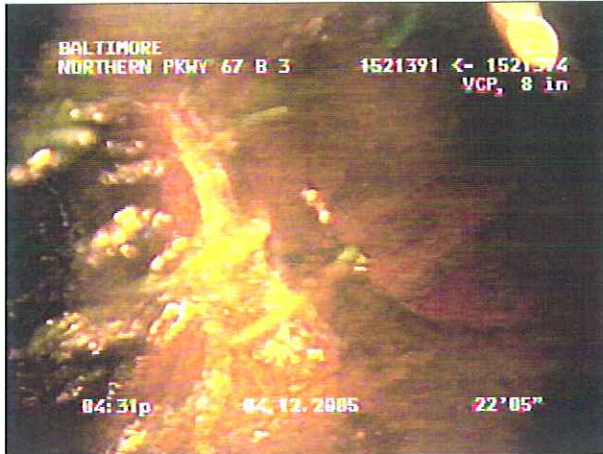
IMAGE: 17a, TAPE #: JAM 4, 00:13:44
22.44FT, service connection with infiltration gushing around at 01 o'clock

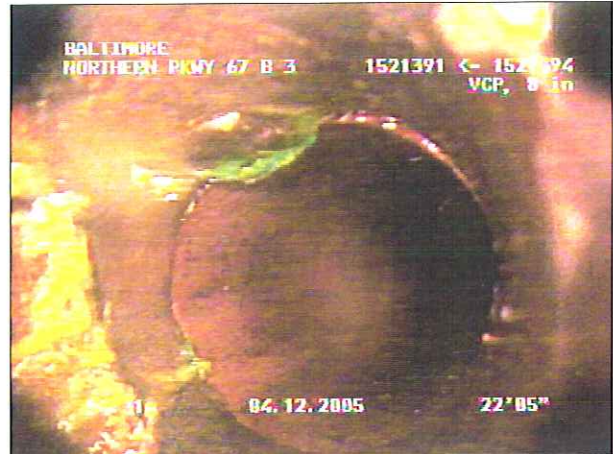
IMAGE: 17b, TAPE #: JAM 4, 00:13:44
22.44FT, service connection with infiltration gushing around at 01 o'clock

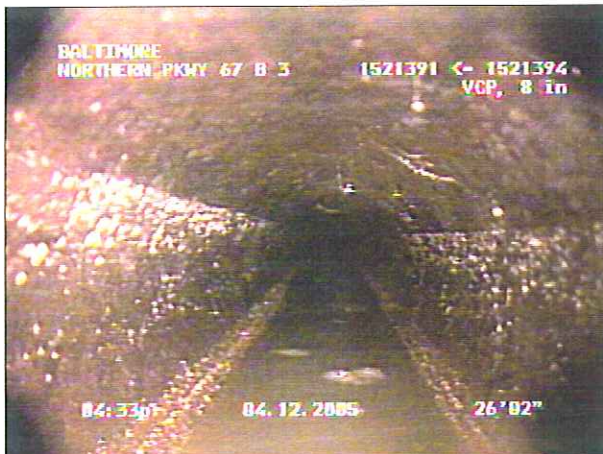
IMAGE: 18a, TAPE #: JAM 4, 00:14:30
26.16FT, inspection ends, NO MORE DYE TEST LEAKS SEEN.
